## Chapter 3

### STRUCTURAL EFFECTS OF THE AGADIR EARTHQUAKE

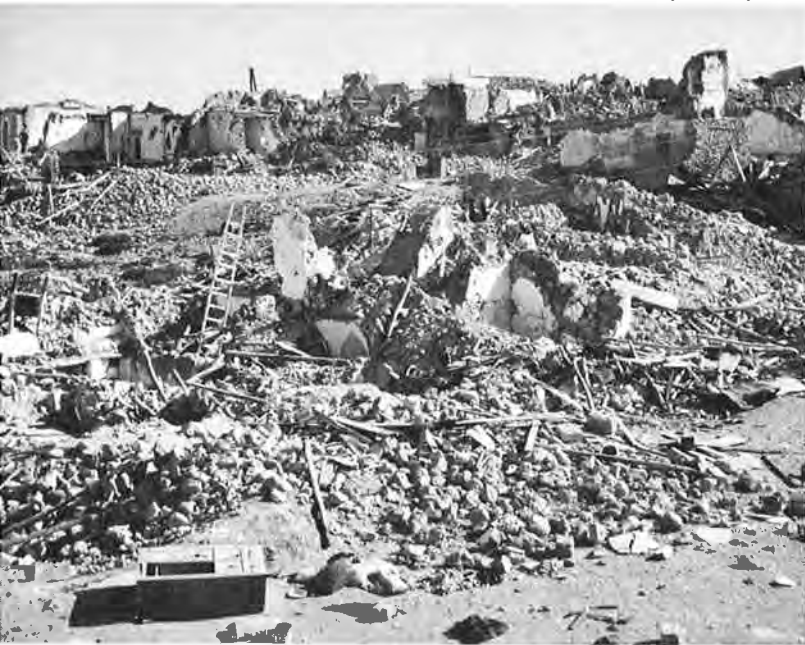
Fig. 15. Collapse of Old Masonry Construction, Yachech District

of these photographs by the way the walls disintegrated completely as they collapsed. The stones simply fell apart, the cementing effect of the mortar was almost nil. The Army bulldozers seen in Figs. 18 and 19 were sent into the Yachech and Kasbah districts after rescue operations were terminated. Their function was to break down the few walls which remained standing and level off and seal cavities in the debris in order to eliminate a potential hazard to the decontaminating teams which were operating in these districts.

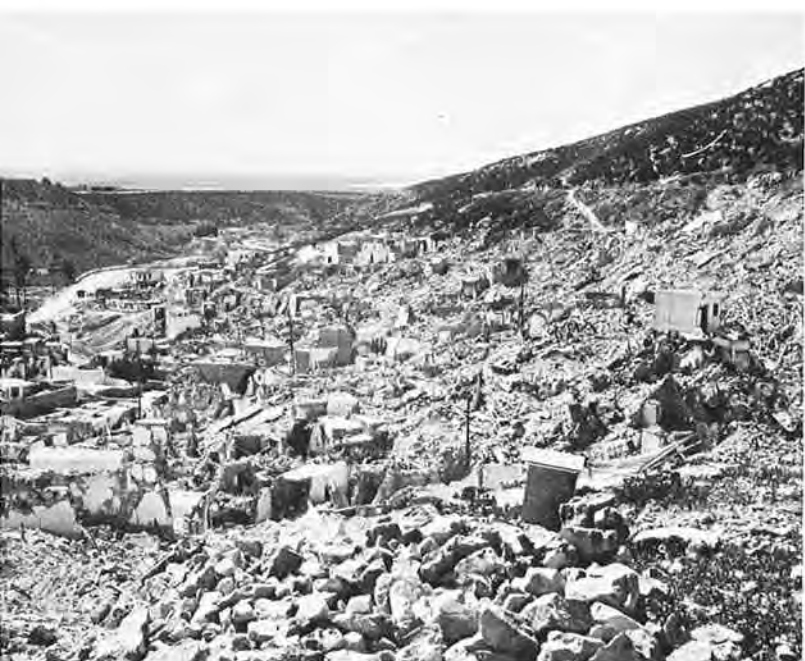
Fig. 17. Typical Street Scene, Yachech District

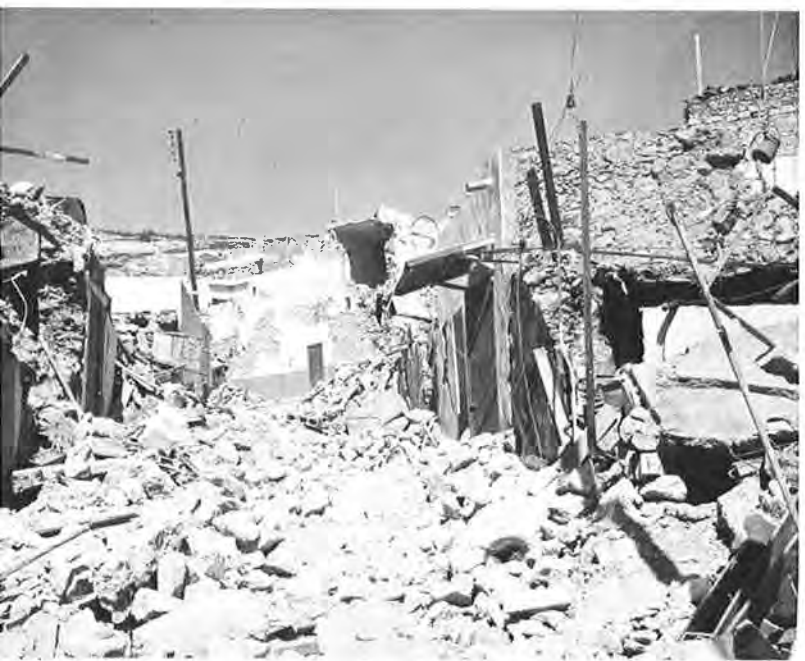
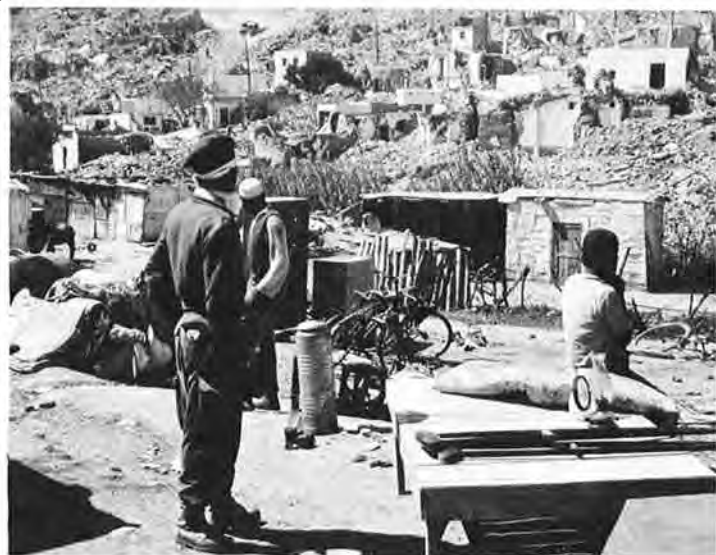
Fig. 18. A Comparison of Damage in the Yachech District

An interesting comparison is presented in FIG. 18 in which the flimsy wooden shacks in the foreground show no apparent effects of the earthquake, while the presumably more substantial stone structures in the rear are seen in all stages of collapse. This is a graphic illustration of the fact that it is not merely the apparent strength of a structure, but rather its true strength in relation to its weight which controls its earthquake resistance. On this basis, the poor performance of these masonry structures is not surprising.

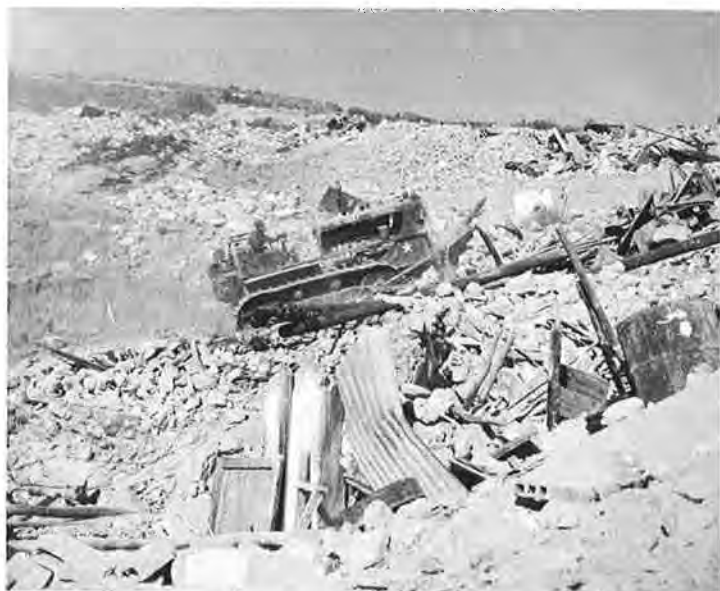
Fig. 19. Leveling the Ruins as a Safety Precaution

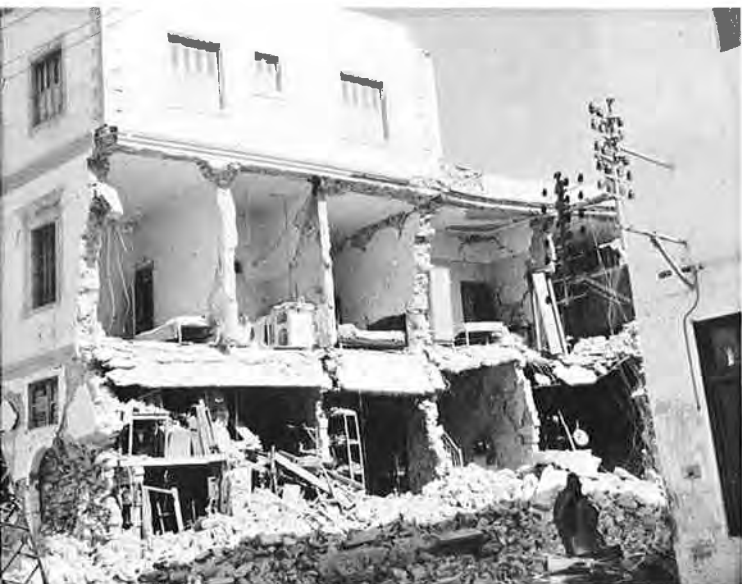
In FIG. 20 is shown a classic example of the earthquake performance of the so-called "modern masonry" structure. The front wall of this structure has collapsed, exposing its internal construction. The earthquake hazard to people in the street presented by this type of construction is very clear. FIG. 21 shows the same street after the bulldozers have cleared a path through it. Building facades on both sides of the street show how plaster has been used to give a smooth surface over the rough masonry structure.

Fig. 20. Typical Failure of Masonry Construction, Talborjt District

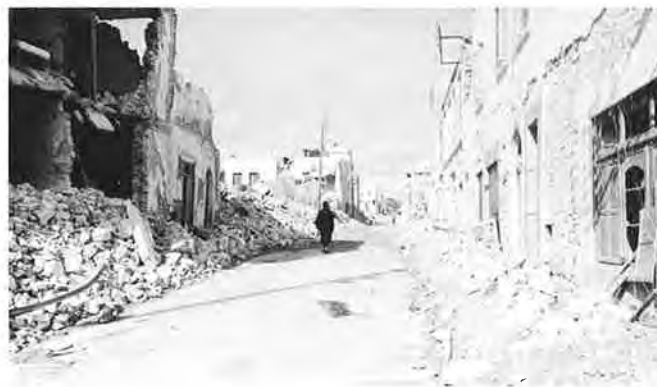
Fig. 21. Scene After Street Has Been Cleared by Bulldozers

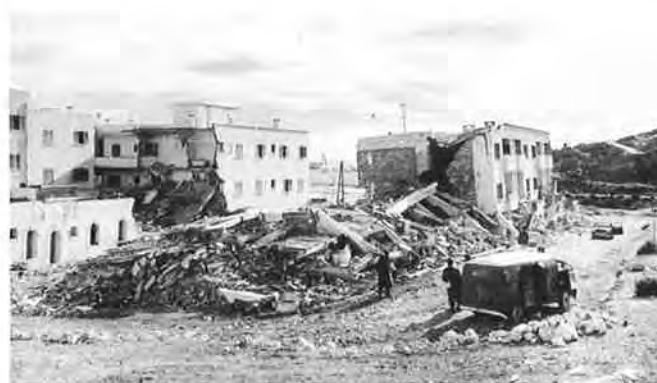
Examples of damage to clay tile masonry structures are shown in Figs. 22 and 23. It appears that no significant improvement in performance is provided by this modern wall filler material, even though the clay tile produces a lighter weight structure than stone. The hollow cellular floor construction in the building shown at the left in FIG. 23 appears to be very lightly reinforced. The building at the right in FIG. 22 is presented in a closer view in FIG. 24. The upper two stories of this structure appear to

Fig. 22. Collapse of "Modern Appearing" Masonry Construction, Talborjt District

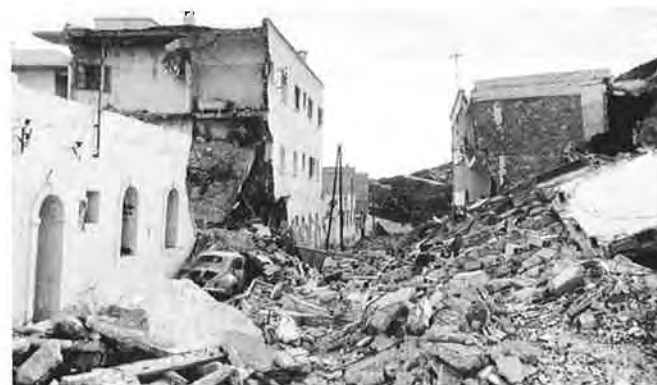
Fig. 23. Close-up of Ruins Shown in Fig. 22

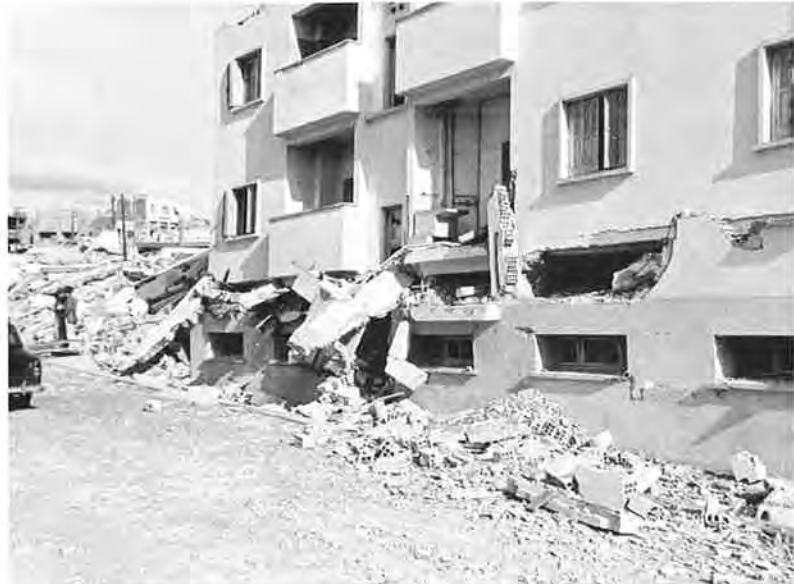
Fig. 24. Complete Collapse of First Story of Building Shown in Fig. 22

be relatively undamaged, but a close inspection reveals that the first story has collapsed completely.

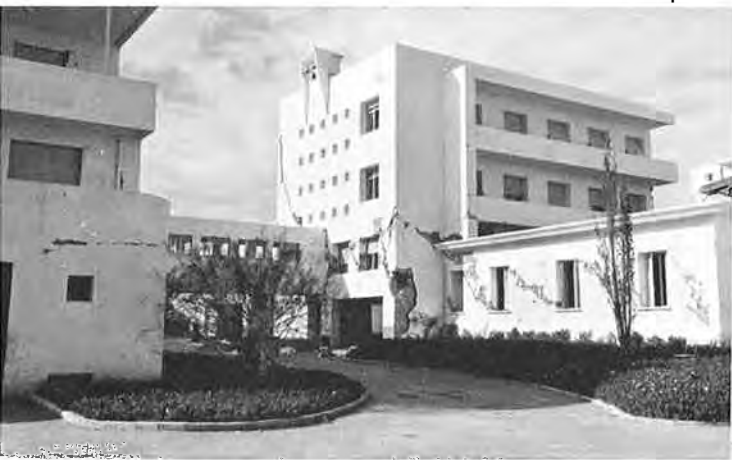
Fig. 25. General View of Lyautey Hospital; Note Diagonal Cracks in Masonry

FIGS. 25 through 29 show the effect of the earthquake on the modern-appearing masonry bearing wall structure of the Lyautey Hospital. In FIG. 25, the diagonal cracks between the windows of the one story portion of the structure to the right are noteworthy in that they are inclined only in one direction: upper left to lower right. This indicates that the primary ground shock was toward the left and rear in this photograph, i.e. toward the northwest. Evidence from many other damaged structures in Agadir indicated this same direction of primary ground motion.

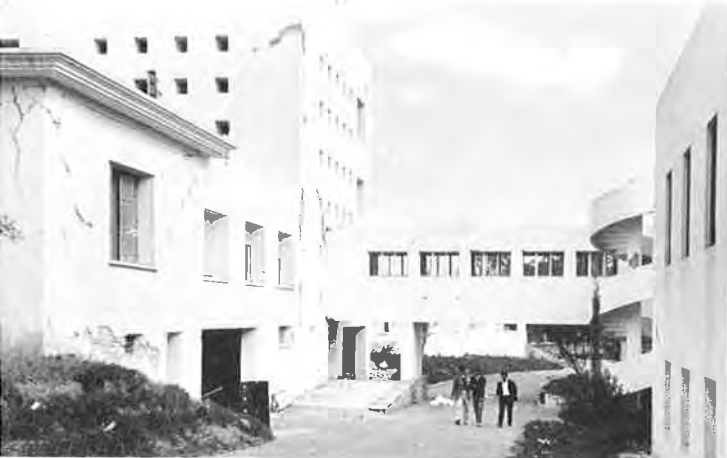
Fig. 26. Lyautey Hospital; Bridge Structure and Spiral Stairway in Good Condition

The relative lack of damage to the spiral stairway and bridge structure shown in FIG. 26 is of interest because one might expect that such structures would be particularly vulnerable to earthquake damage. However, it was necessary for the designer to provide adequate reinforcing and continuity in these structures in order that they might resist static, vertical load. Thus, even though lateral forces may not have been considered in their design, they had a basic requisite of an earthquake resistant structure, i.e. they were well tied together. The performance of these and similar examples throughout the city demonstrated that it is not impossible to design structures to resist accelerations such as were produced in the Agadir earthquake; in fact, they tend to indicate that the magnitude of the ground accelerations developed here was not extremely great.

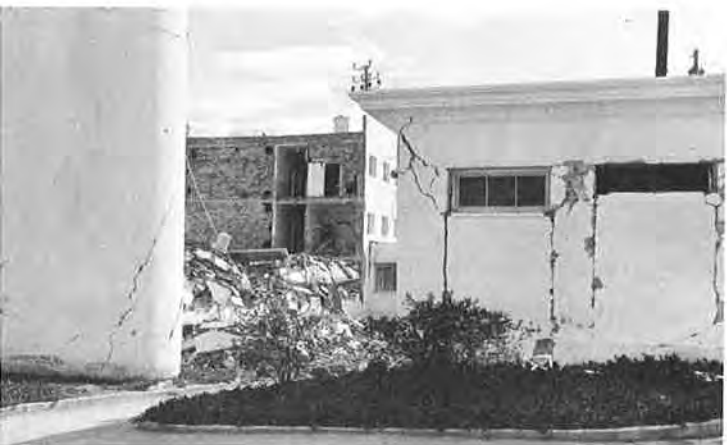
Fig. 27. Collapsed Maternity Wing, Lyautey Hospital

The opposite side of the main hospital structure is shown in FIG. 27. The wing which collapsed was the maternity ward of the hospital. Fortunately, it stood for 15 minutes after the earthquake, allowing time for its evacuation before the final collapse, and no one was injured in the failure of this structure. FIG. 28 is a closer view of the same structure, showing the

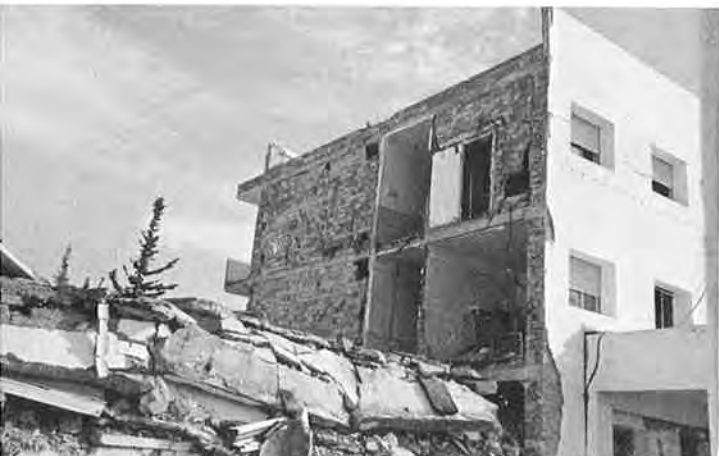
Fig. 28. Close-up of Collapse; Note Lack of Connection to Adjacent Structure

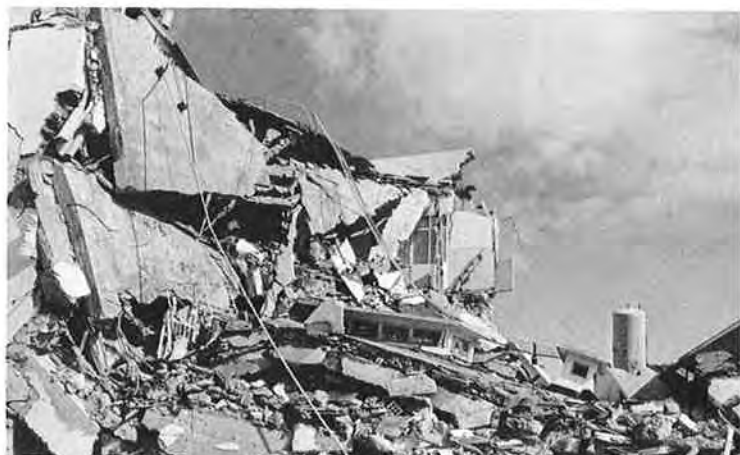
Fig. 29. Remains of Maternity Wing
