CONCRETE STRUCTURES

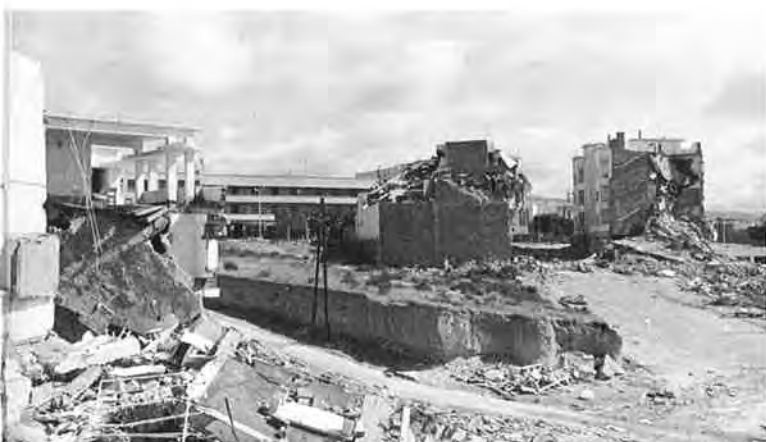
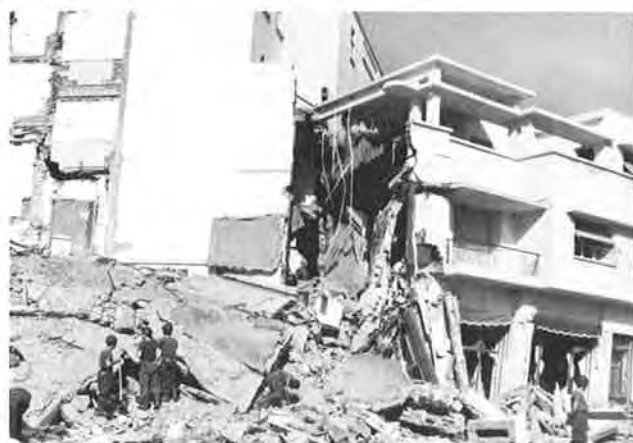
The New City also presented many examples of severely damaged or completely collapsed masonry structures, a few of which are shown in FIG. 30. The structure in the left foreground of FIG. 30 is shown again in FIG. 31, a complete collapse typical of many in this district. The street at the right of FIG. 30 is shown in a close-up view in FIG. 32. The structure to the left in FIG. 32 was the Sud Building, a reinforced concrete frame structure which will be discussed in the next section of this chapter. The building to the right was a masonry structure part of which collapsed completely, the remainder being very severely damaged. The other side of this building is shown in FIG. 33.

The vertical embankment maintained by the soil at the edge of the streets in FIG. 30 is of interest. Clearly the ground was extremely hard and well compacted, and even the very sharp earthquake shock caused very little sloughing of the embankment. Such conditions were characteristic of the entire city. There was no evidence anywhere (except in the port) of any foundation failures or damages caused by poor soil conditions.

Fig. 30. General View in New City; Sud Building in Center

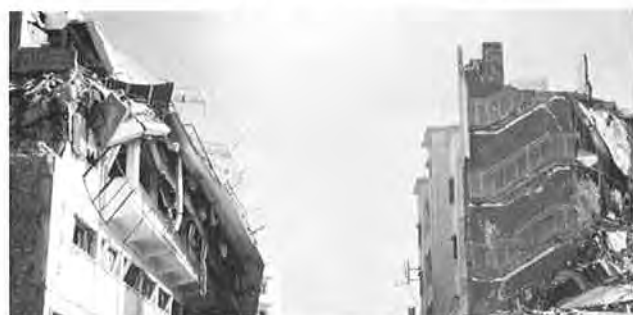
Fig. 31. Collapse of Typical New City Masonry Construction

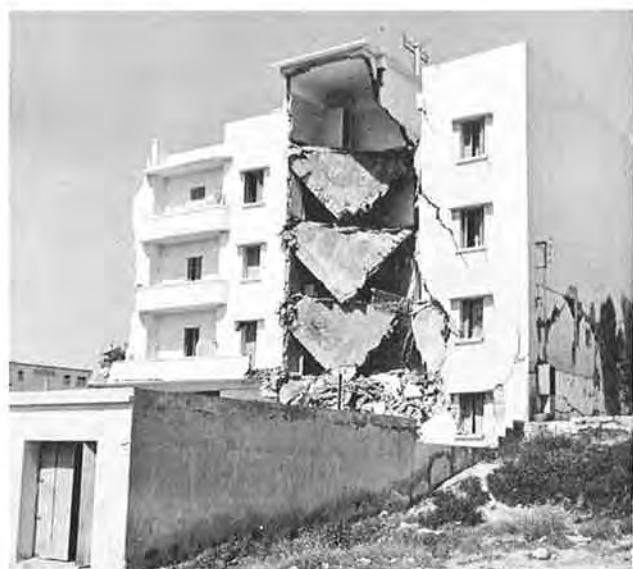
Fig. 32. View of Reinforced Concrete Sud Building on Left, Masonry Structure on Right

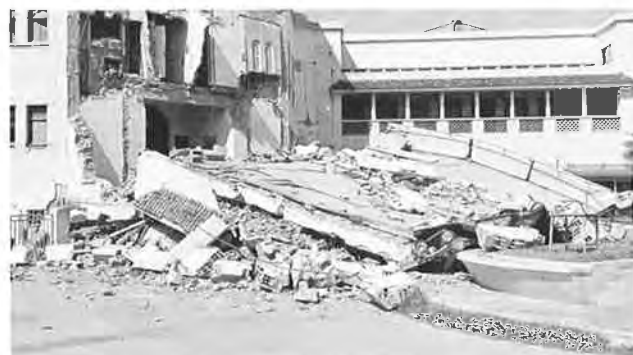
Fig. 33. Collapse of Masonry Bearing Wall Leaves Floor Slabs Unsupported

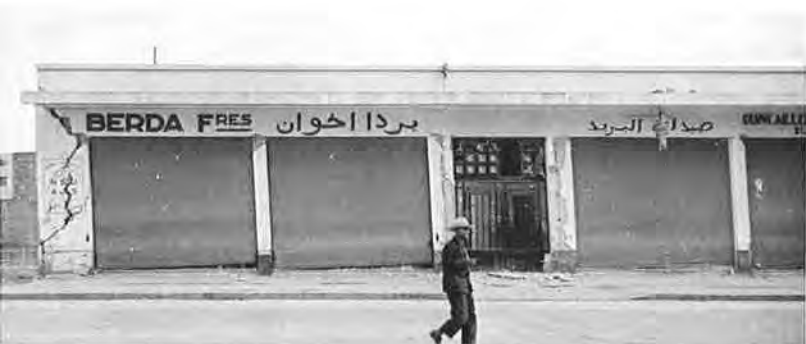
Fig. 35. Racking of Buildings in First Story

FIGS. 35 and 36 show interesting examples of earthquake damage to small masonry buildings. These two buildings faced each other across a street in the New City. The street was oriented NW-SE, and it is apparent that the principal ground shock was directed parallel with the axis of the street, toward the northwest. The bases of both buildings lurched in this direction, leaving the upper part of the structure behind. It seems likely that the flexible steel screens which were rolled down to cover the store windows provided the lateral shearing resistance which prevented complete collapse of these structures.

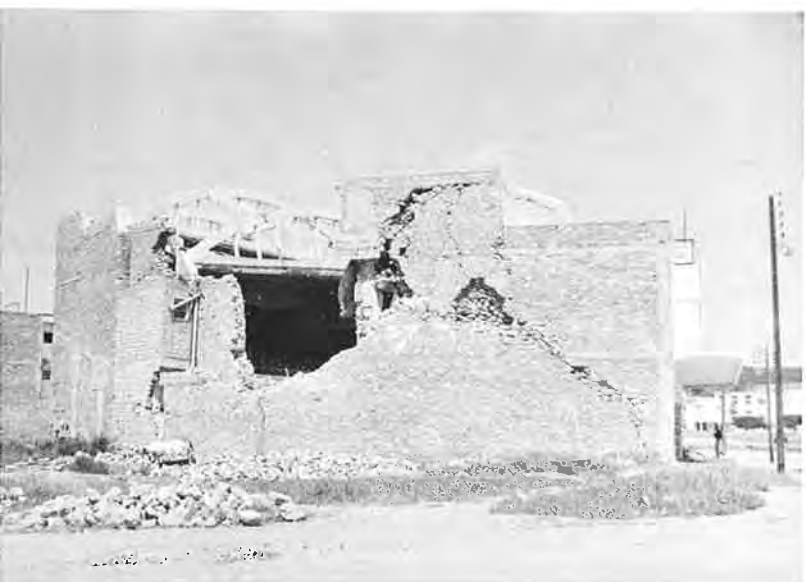
Fig. 36. Note Bracing Effect of Flexible Steel Screens

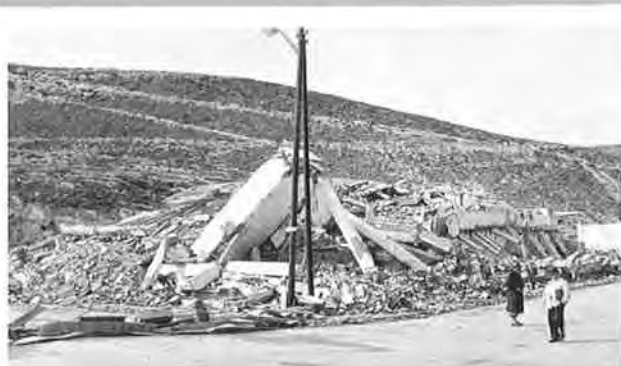
One of the most spectacular and tragic structural failures in Agadir was that of the Immeuble Consulaire. This was an eight-story office and apartment building, built between 1952 and 1954; at the time of the earthquake, it housed approximately 300 people. Its very attractive architectural style is shown in Figs. 38 and 39. The total collapse of this structure is evident from the remains shown in Fig. 40, or in Fig. 41 where the successive floor panels are seen piled one on another.

Fig. 40. Immeuble Consulaire from the South, After the Earthquake

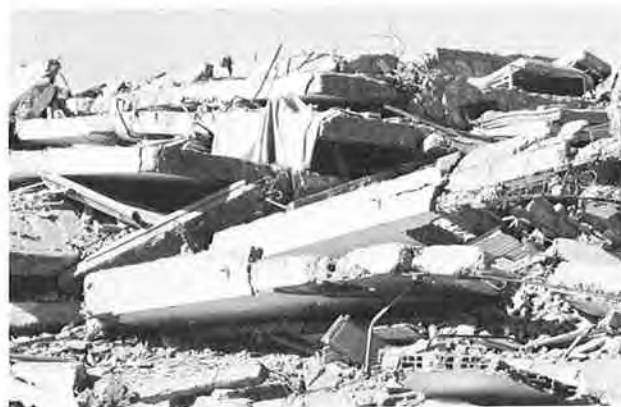
Fig. 41. Immeuble Consulaire, Note the Stack of Successive Floor Slabs

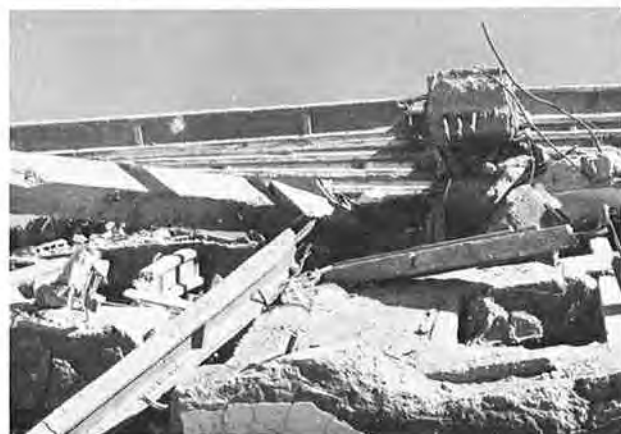
Some indications of the basic structural weakness which led to this collapse may be noted in other views of the shattered remains. In Figs. 42 and 43 are seen the precast floor beams which were used throughout the structure. It is apparent that these supported the floor panels but were not actually integrated into them, with the result that the whole system simply came apart. The ultimate cause of the collapse of this structure was the lack of any primary mechanism for resisting lateral forces, resulting in fracture of the beam-column connections under the action of the earthquake. The lack of continuity between the various elements of the structure then permitted it to disintegrate as the beam-column connections ruptured.

Fig. 42. Precast Floor Beams Used in the Immeuble Consulaire

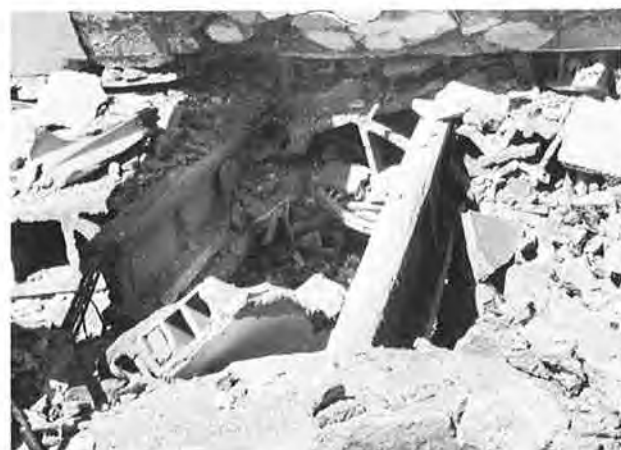
Fig. 43. Precast Floor Beams and Hollow Precast Floor Panels

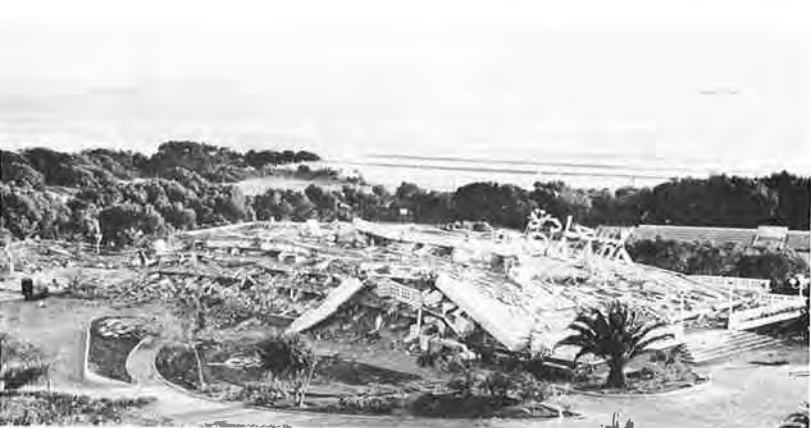
Fig. 45. Saada Hotel from the Northeast, After the Earthquake

The Saada Hotel provided the most publicized structural collapse of the earthquake, primarily because of the large proportion of Europeans and Americans who were guests of the hotel at the time of the tragedy. Built in 1951–52, this hotel had been one of the most fashionable and luxurious in the city (Fig. 44), but the broken remains which were left after the earthquake (Fig. 45) gave little evidence of its former grandeur. As in the case of the Consulaire Building, the structure collapsed completely, leaving the floor slabs piled one on another. The details of the failure were somewhat different in this case (the floor system included cast-in-place rather than prefabricated joists, as may be seen in Fig. 46), but the basic mechanism was similar. Beam-column joints were inadequately reinforced, if at all (Fig. 47), and the reinforcing in the flexural members was not designed and placed (Fig. 48) to resist substantial dynamic lateral forces. Thus, under the action of the earthquake, the joints in the vertical members ruptured, and lack of continuity permitted the entire structure to come apart.

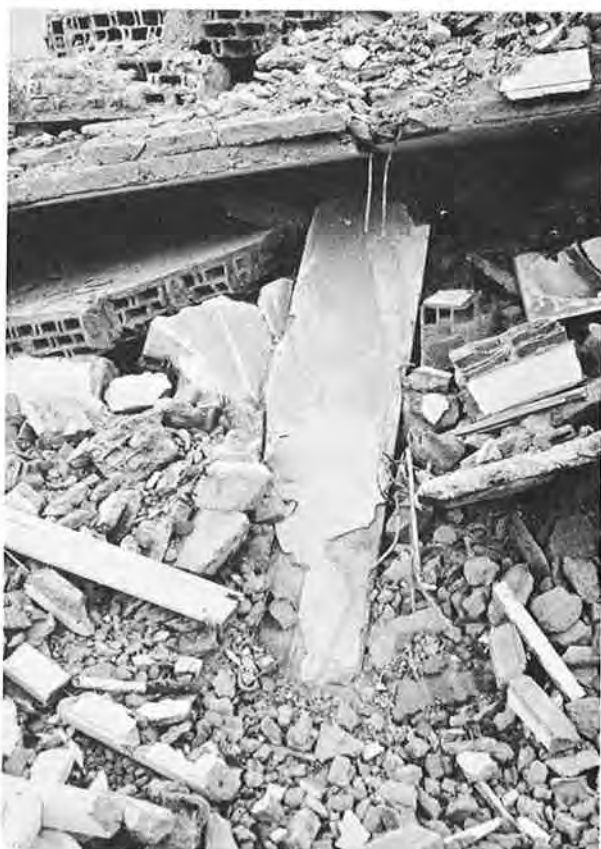
Fig. 46. Hollow Precast Floor Panels of the Saada Hotel

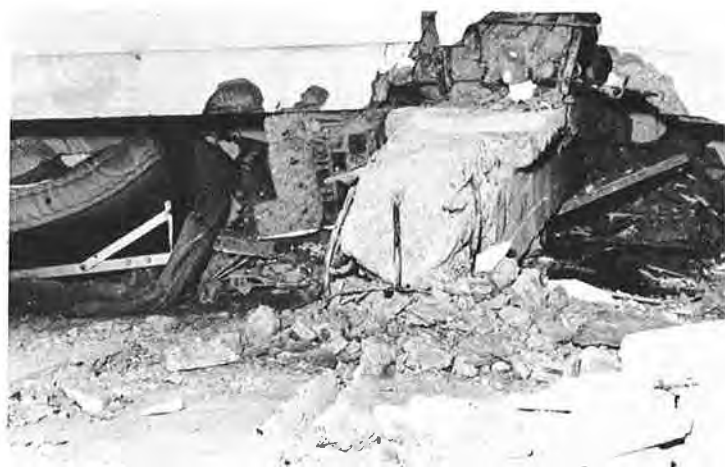
Fig. 48. Saada Hotel Detail, Note Fracture of Beam and Girder

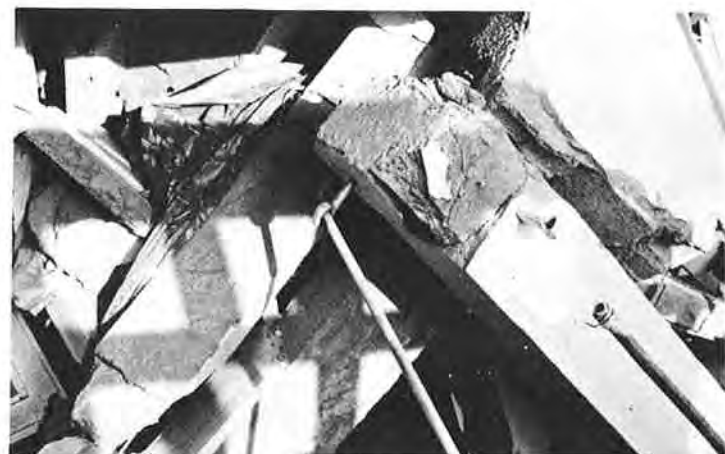
Fig. 47. Saada Hotel Detail, Note Lack of Continuity Between Members

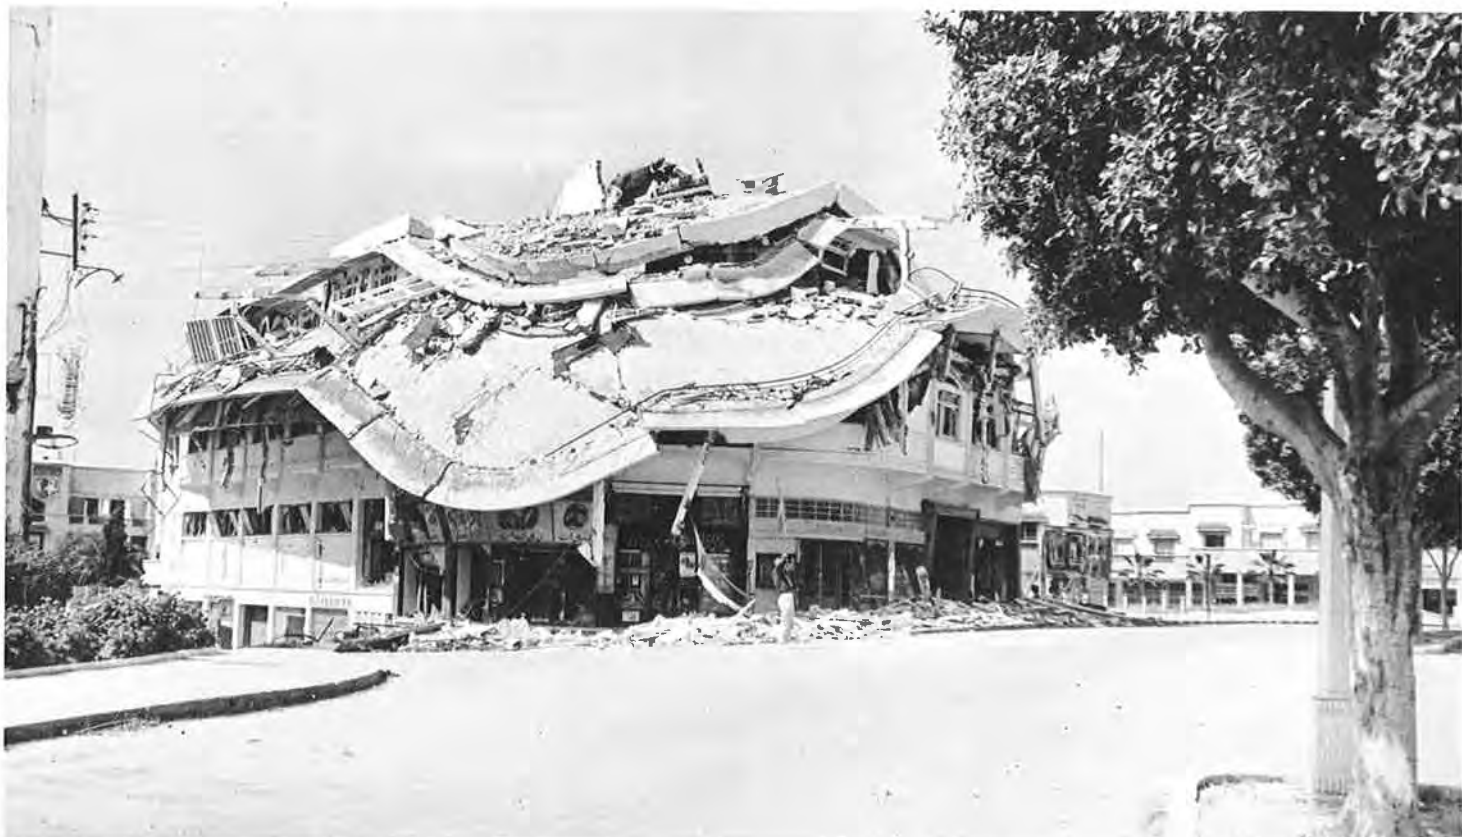
There were several other complete collapses of reinforced concrete structures, but little additional information can be gained from a study of the debris of such total collapses. Some of the structures which collapsed only partially are of interest, however, and one of the most instructive examples was the Sud Building, located in the New City. This structure is shown in the center of FIG. 30 and at the left of FIG. 32. A front view of the building is presented in FIG. 49. At the street level, this four-story structure was approximately rectangular in shape, but in the top three stories it was a rounded L-shape with the curve of the L facing the street corner shown in FIG. 49. The structure was cantilevered out over both of the streets on which it faced, with the projection of the fourth floor deck extending almost 10 feet beyond the face of the building. The weight of this overhang, combined with the sudden lurch of the ground toward the rear of the building (i.e. northwest) caused the shearing failure of the masonry filler walls and collapse of the columns in the third floor level. At the curve of the L the fourth floor columns collapsed as well. Other views of the collapsed structure are shown in FIGS. 50 and 51.

Fig. 49. Sud Building from the Southeast, Third Story Has Collapsed

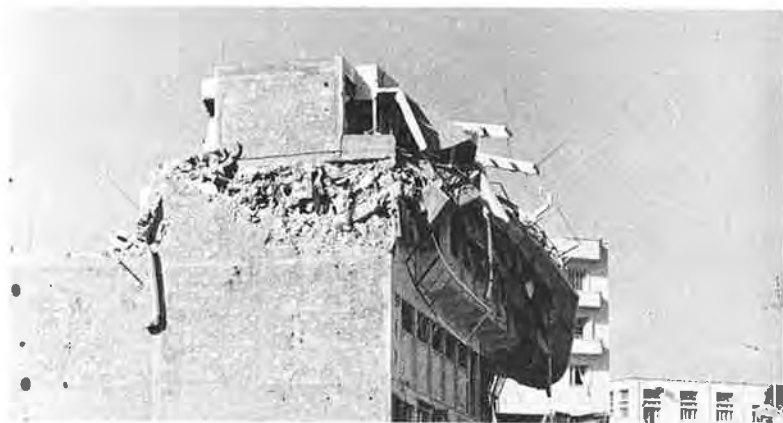
Fig. 50. Sud Building from the Southwest, Note How Third Story Has Collapsed Toward the Right (SE)

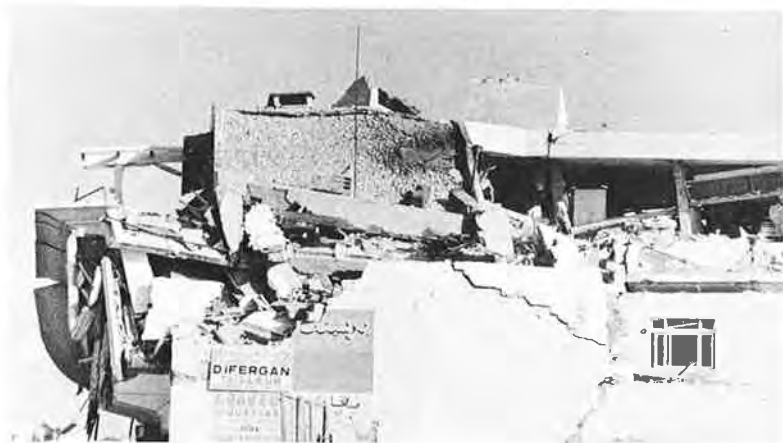
Fig. 51. Sud Building from NE, Overhang of Balcony Is Visible
