CONCRETE STRUCTURES

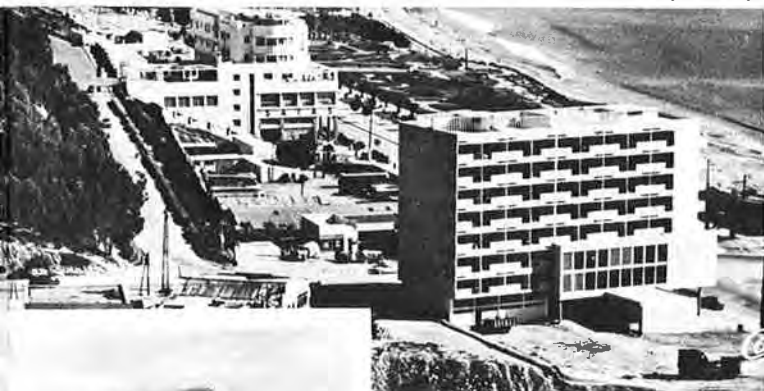
Fig. 38. View of Immeuble Consulaire from the Kasbah Hill, Before the Earthquake

One of the most spectacular and tragic structural failures in Agadir was that of the Immeuble Consulaire. This was an eight-story office and apartment building, built between 1952 and 1954; at the time of the earthquake, it housed approximately 300 people. Its very attractive architectural style is shown in Figs. 38 and 39. The total collapse of this structure is evident from the remains shown in Fig. 40, or in Fig. 41 where the successive floor panels are seen piled one on another.

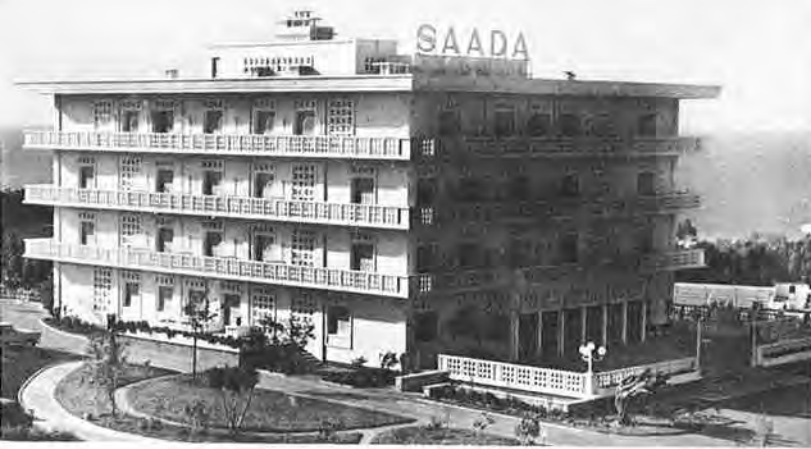
Fig. 44. Saada Hotel from the Northeast, Before Earthquake

The Saada Hotel provided the most publicized structural collapse of the earthquake, primarily because of the large proportion of Europeans and Americans who were guests of the hotel at the time of the tragedy. Built in 1951–52, this hotel had been one of the most fashionable and luxurious in the city (Fig. 44), but the broken remains which were left after the earthquake (Fig. 45) gave little evidence of its former grandeur. As in the case of the Consulaire Building, the structure collapsed completely, leaving the floor slabs piled one on another. The details of the failure were somewhat different in this case (the floor system included cast-in-place rather than prefabricated joists, as may be seen in Fig. 46), but the basic mechanism was similar. Beam-column joints were inadequately reinforced, if at all (Fig. 47), and the reinforcing in the flexural members was not designed and placed (Fig. 48) to resist substantial dynamic lateral forces. Thus, under the action of the earthquake, the joints in the vertical members ruptured, and lack of continuity permitted the entire structure to come apart.
